MPE720 improvement item and bug fix change

1. Function addition and improvement item

Items added and features improved from MPE720 version 5.35 to version 5.36 are as follows.

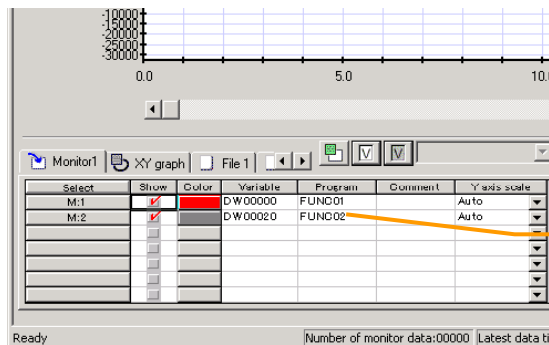
No.1 Trace function for D register of user function

A local register of the user function (D register) was able to be defined as a register for the trace.

D register of the User Function is specifiable.

* This function can be used since controller Ver2.47.

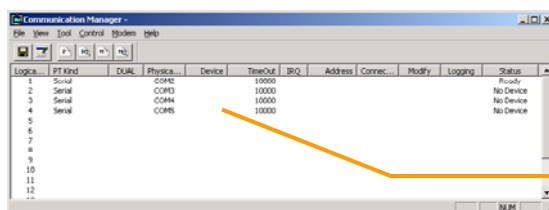
No.2 Allocation number extension of serial port of communication process

These were able to be allocated up to four though serial ports were able to be allocated to the port in the communication process only up to two at the same time up to now.

Serial can be allocated up to four at the same time.

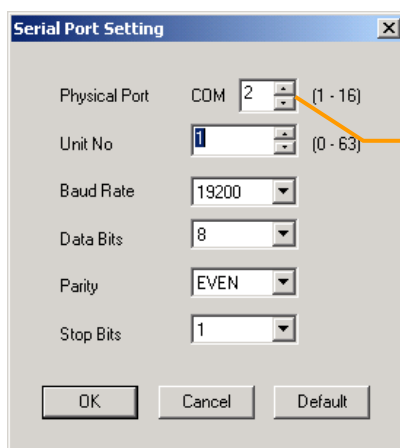
No.3 Communication process COM port number extension

Because the number of use COM ports increased with USB-serial converter etc, the COM port number was able to be set even to the greatest 16 on the serial port casting off screen of the Communication process.

The selection of the COM port was extended to 1-16.

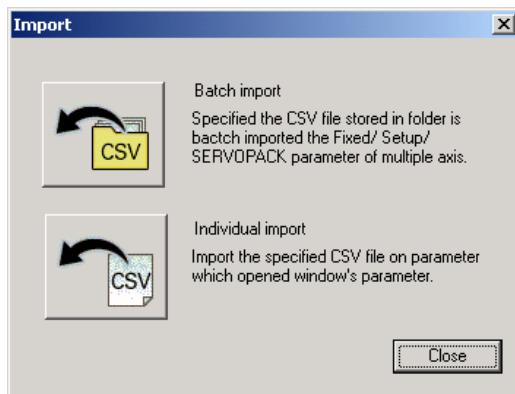
No.4 Motion parameter import export function

It was made importing of the fixed parameter, the configuration parameter, and the servo parameter of the MP2000 series by Comma Separated Value, and to export.

Managing the motion parameter that was able to be managed only by each PLC folder by Comma Separated Value according to this function becomes possible. As a result, a certain shaft parameter is reflected in plural shafts, and preserving the set point of the motion parameter by Comma Separated Value becomes possible.

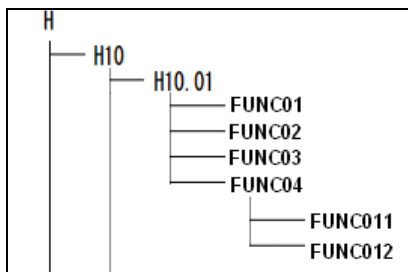
No.5 Print system chart

When the print was executed, the function to read the dependence in the user function drawing and to print the system chart was made.

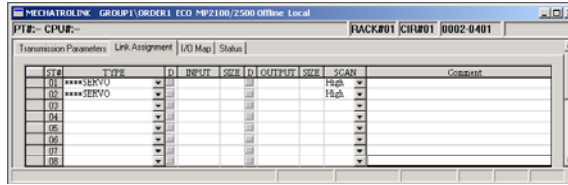
No.6 For ****SERVO (MECHATROLINK module)

**** SERVO module of a possible casting off was added as a general-purpose MECHATROLINK servo. As a result, it ..MECHATROLINK servo made of third party becomes a possible casting off.

****SERVO doesn't have the servo parameter.

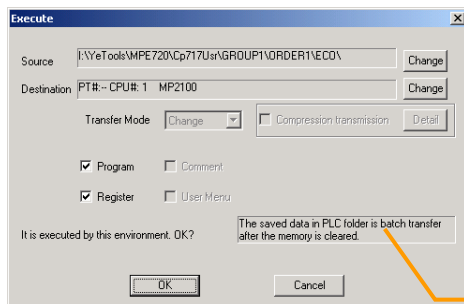
No.7 Transferring message improvement

The message concerning each transferring operation was displayed on the all transfer and the individual transfer screen.

The transferring operation explanation of the object is displayed.
