MPE720 improvement item and bug fix change

1. Function addition and improvement item

2. Correction content explanation

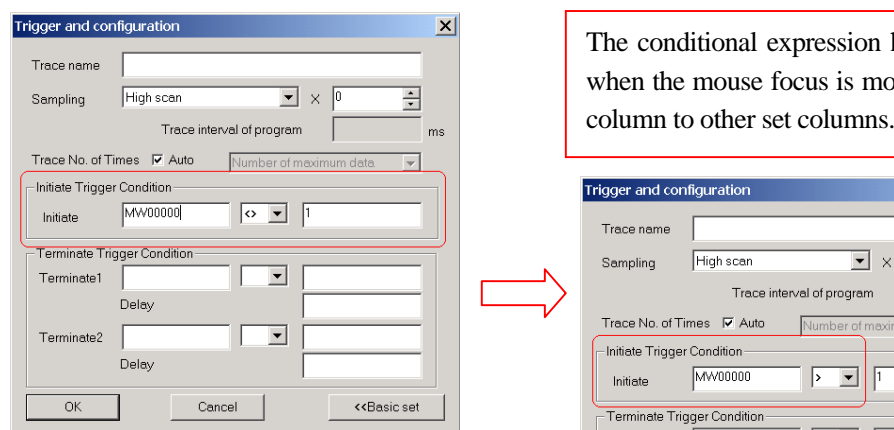
No.11 Data trace condition setting defective operation

When the mouse focus was moved after the trace manager set the trigger condition, the trigger condition had been initialized. Therefore, this was corrected.

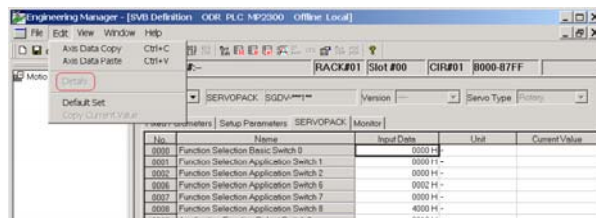
No.12 Servo pack details menu operation trouble

"Details" in the edit menu of the servo pack parameter screen did not operate correctly. Therefore, this was corrected.

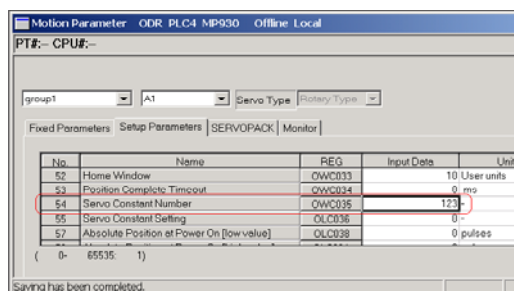
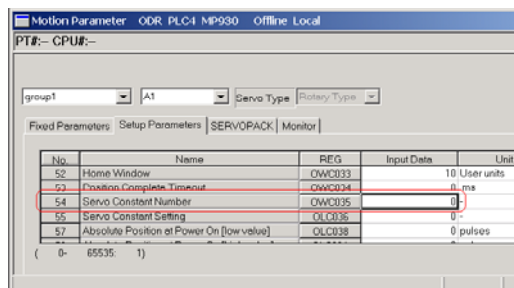
No.14 Saving trouble of setup parameter of MP930

When the value of setup parameter No54 was input and saved on the motion parameter screen of MP930, it seemed to have completed saving normally. However, it returned to the value before it saved it when the tab was switched, and the value was not saved. Therefore, this was corrected.

It returns to the value before it saves it when the tab is switched.

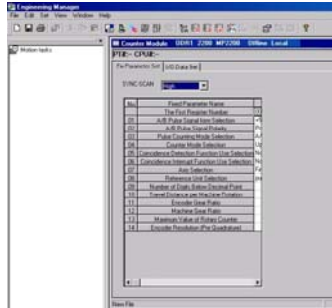
No.15 Detailed screen display trouble of CNTR-01 module

The detailed definition screen was interrupted in the blank part when a task manager and a quick watch were opened when a detailed screen of the CNTR-01 module was opened, and a set column was not seen occasionally. Therefore, this was corrected.
