# **Upgrade Information of MPE720 Version 5.41**

## 1. Added and Improved Functions

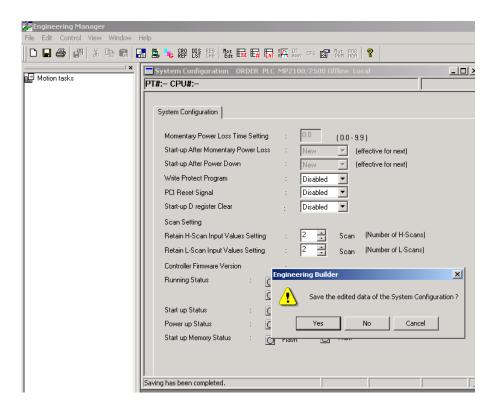
## No.6 Bug of Save confirmation in System Definition

It was modified that the message was displayed only when there was an edit. Because the message "Save the edited data of the System Configuration?" was displayed though the System Definition was saved when log off the PLC folder with the cursor moved to "Retain H-Scan Input Values Setting" or "Retain L-Scan Input Values Setting" column of "Scan Setting" of the System Definition.

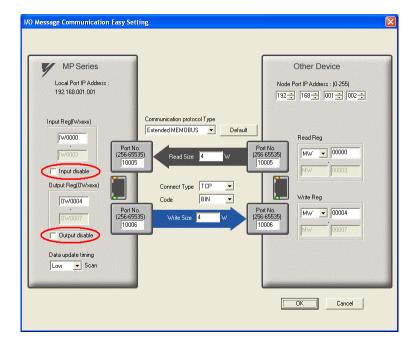
#### No.7 Bug of Input/ Output disable operation of I/O message communication.

The operation of "Input disable" and "Output disable" were different on I/O message communication of 218IFA detail definition window.

"Input disable" is the check box is checked, the check is maintained until the check box is cleared. But "Output disable" is the checkbox will be unchecked when "Protocol type" is changed or "Default setting" button of the Easy Setting is clicked. So, The value of "Output disable" was not cleared with the "Default" transaction when "Protocol type" is changed or "Default setting" button of the Easy Setting is clicked.

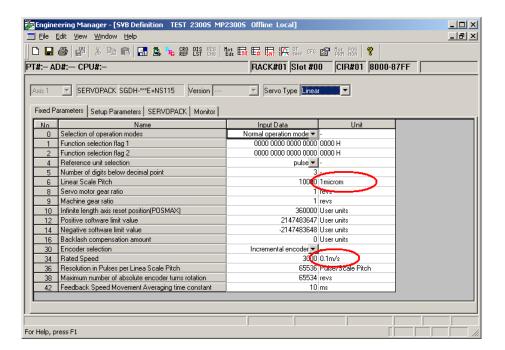
## No.9 Bug of unit of display of SVB linear type for MP2310/ MP2300S.

It was modified that when the Servo Type of motion parameter of SVB was set in the Linear, the unit of No.6 "Linear Scale Pitch" was displayed by mistake as "microm". And, it was modified that the unit of No.34 "Rated Speed" was displayed by mistake as "0.1m/s".

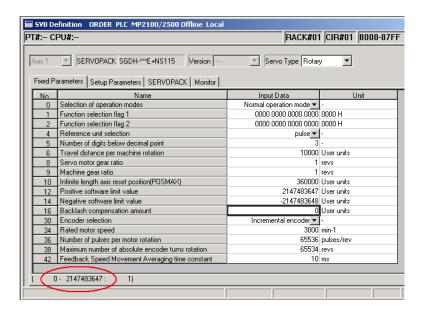
## No.10 Bug of the fixed parameter input range.

It was changed from "0 to 2147483647" to "-2147483648 to 2147483647". Because the setting range of the Fixed parameter No.16 "Backlash compensation amount" of MP2100 built-in SVB was "0 to 2147483647".

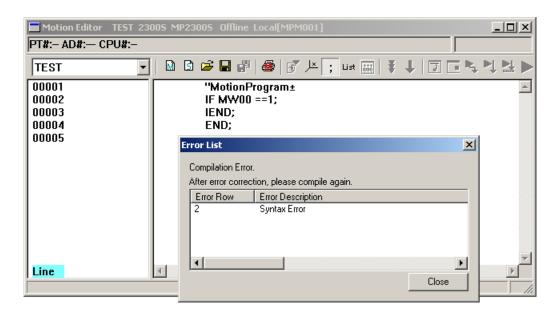
## No.12 Bug which using one-byte katakana in the motion program.

It was modified that it was likely to become an error when saving or wrong code is generated occasionally which using one-byte katakana (character code is 0x80 or more) in the motion program.
