Upgrade Information of MPE720 Version 5.42

1. Added and Improved Functions

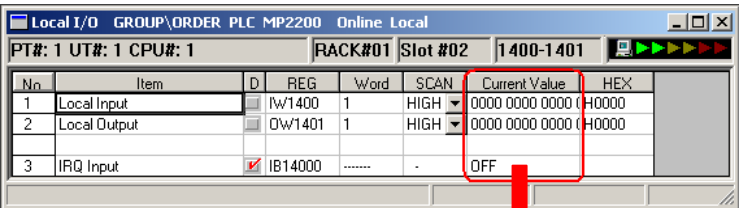
When the current value is get of I/O and BIN is displayed like the LIO module and the DO module, etc., the digit number of display might not be able to display 16 bit by the system requirements. It was corrected that the width of the row in the grid was able to be treated in changeability to display it even for this case.

When "Current Value" cannot display 16 bit.

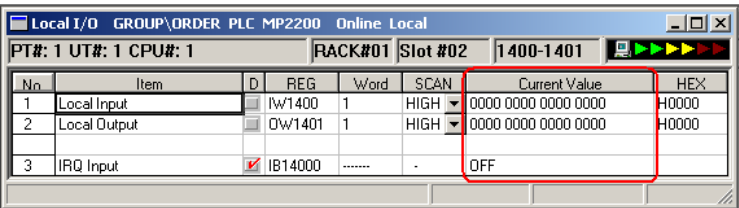
It came to be able to display 16 bit by expanding the width of the row of "Current Value".

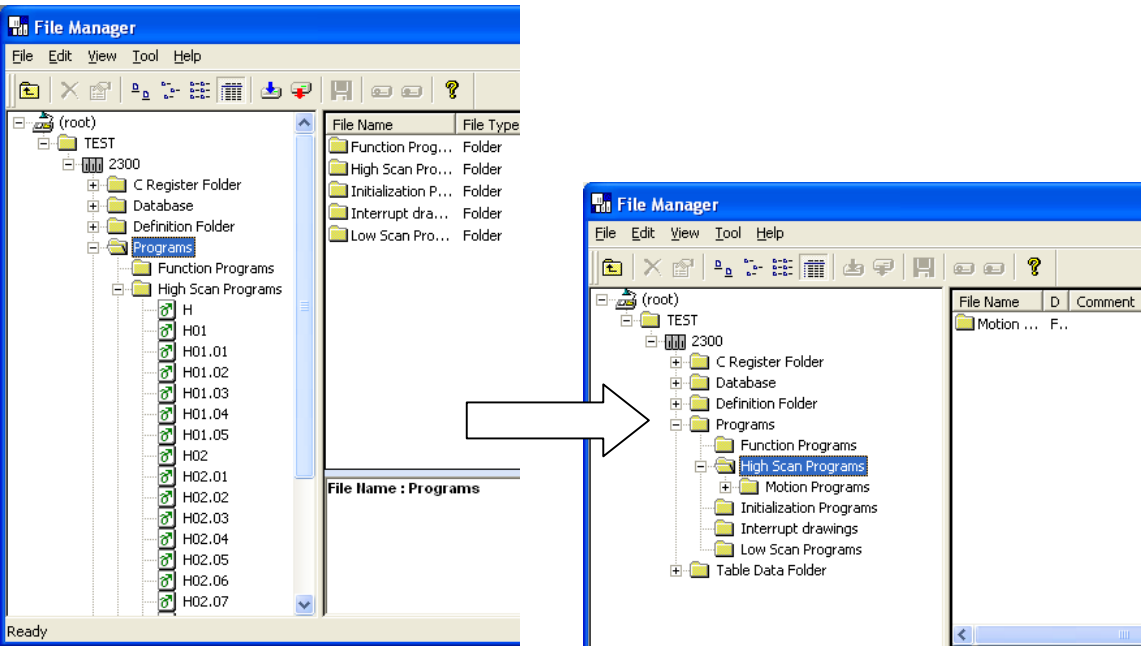
No.7 The New Ladder Map Information Deletion Processing was Invalidated.

This is modified correctly that when the file manager terminated abnormally while using the new ladder editor, the phenomenon the drawing list's disappearing from the file manager had been generated.

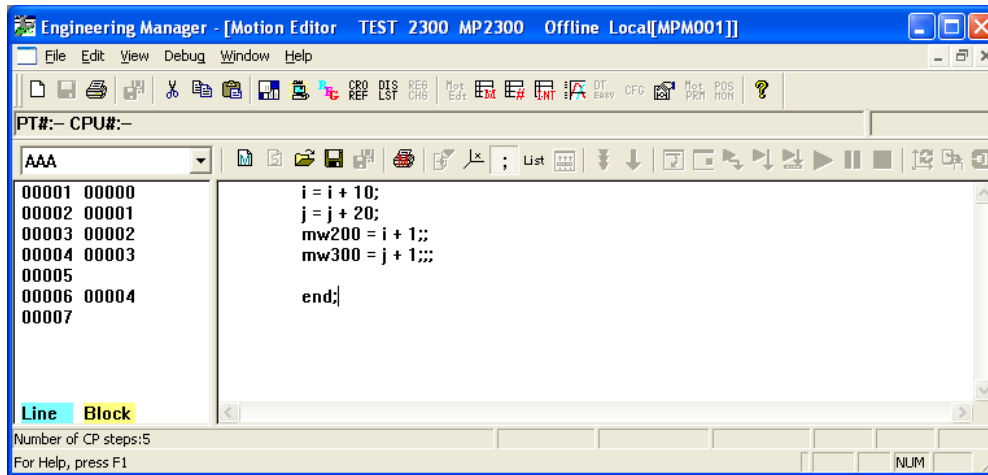
No.9 Bug Fix of Index Operation of Motion Program

When the index register (i and j) was operated as a register (not index of other register), the operation was not normally possible. And then, it was modified correctly.
