Upgrade Information of MPE720 Version 5.44

1. Added and Improved Functions

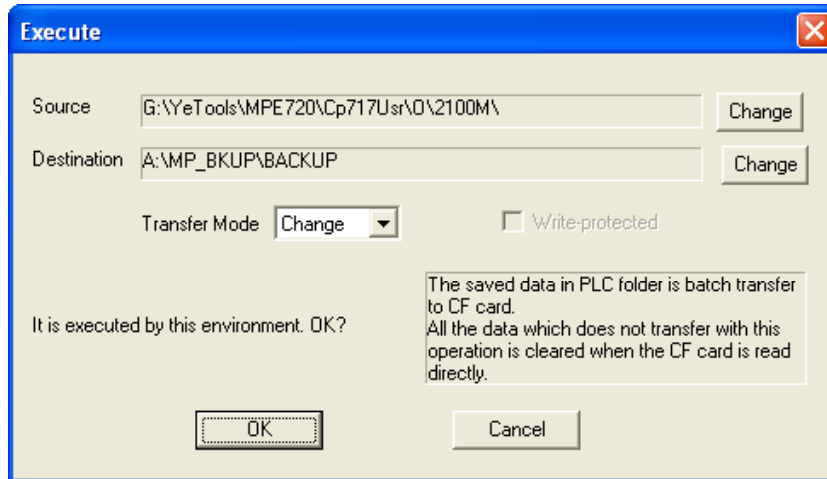
No.6 Improvement of transfer function.

In transfer, when the compression transmission is selected, an internal transfer mode is transferred by "New".

However, it was displayed on the transfer screen, "Change".

Therefore, the transfer mode when the compression transmission was selected displayed, "New".

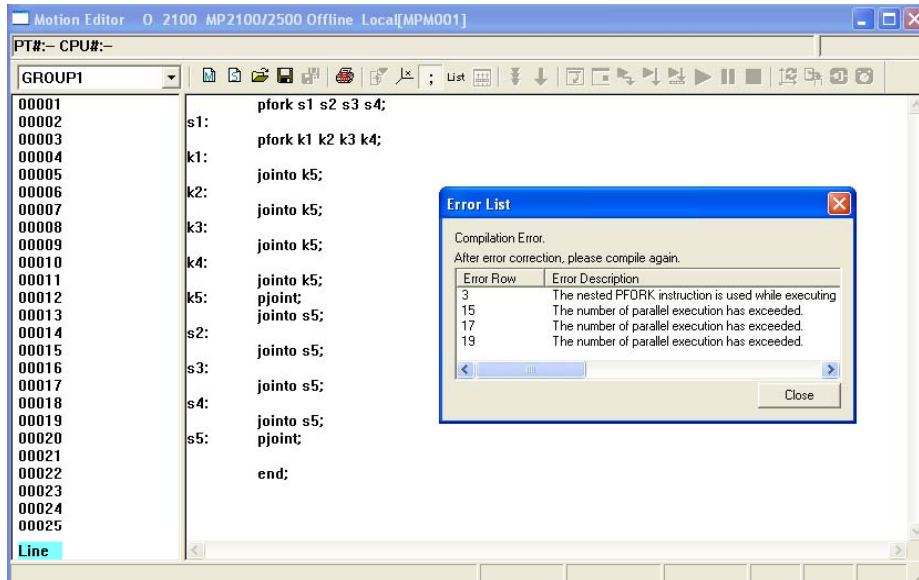
No.10 Detection of the PFORK nest error.

The saving error occurs if the nest of PFORK in the motion program at on-line, but no error occurs at off-line. Therefore, this was corrected.

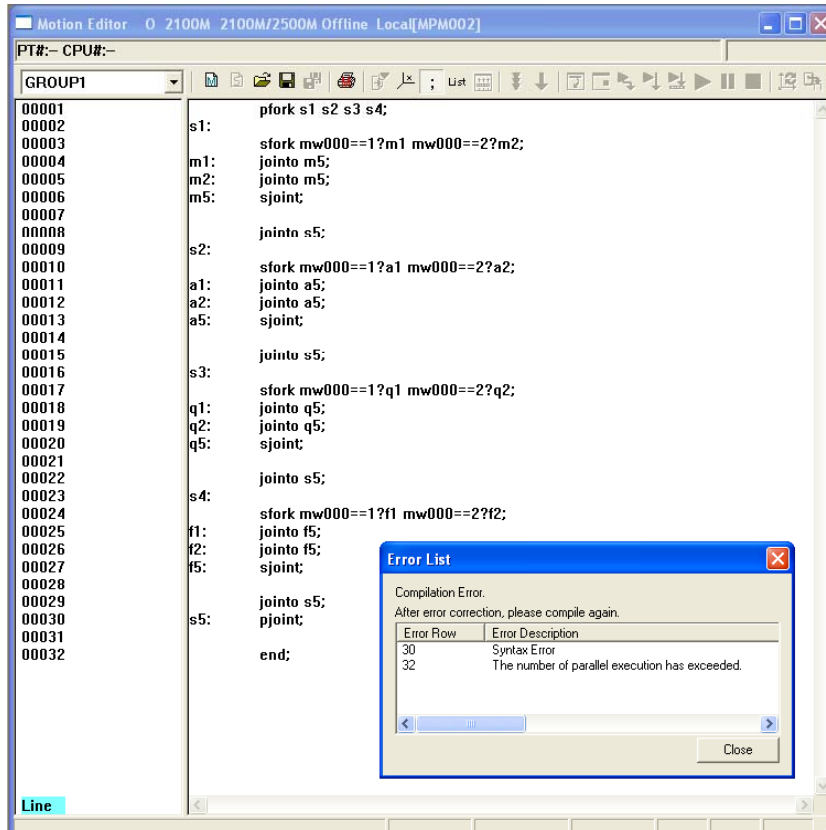
No.11 Improvement of motion program PFORK-SFORK saving.

The number of parallel execution occurred when four diverged parallel because of the PFORK instruction, and the SFORK instruction was used in each parallel processing and, up to now, the error of "The number of parallel execution has exceeded." had occurred in spite of in the limitation. Therefore, this was corrected.

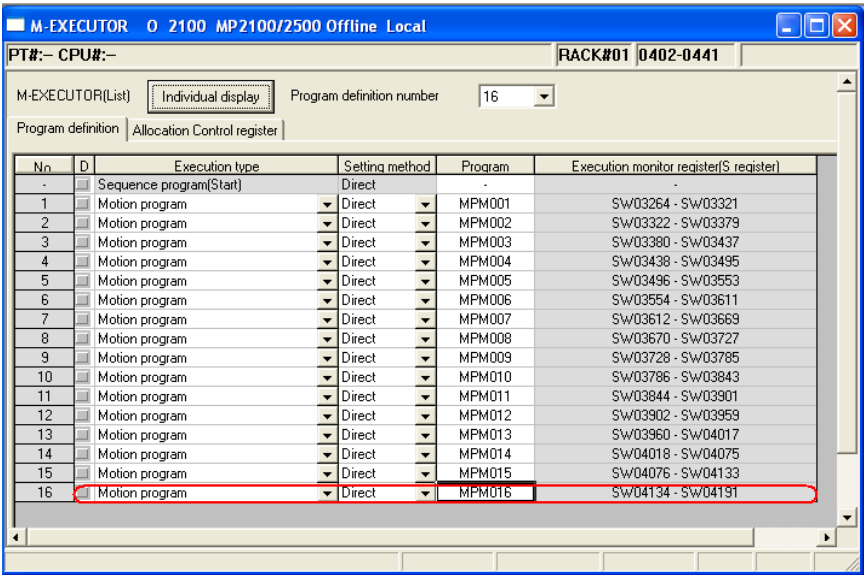
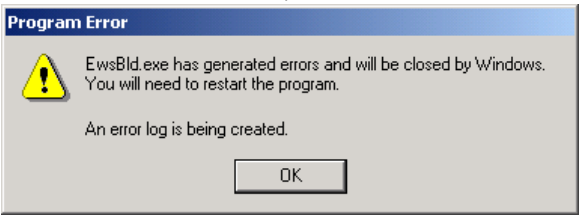
No.14 M-EXECUTOR definition saving trouble.

It terminated abnormally when 16 programs were registered on the M-EXECUTOR screen occasionally. Therefore, this was corrected.

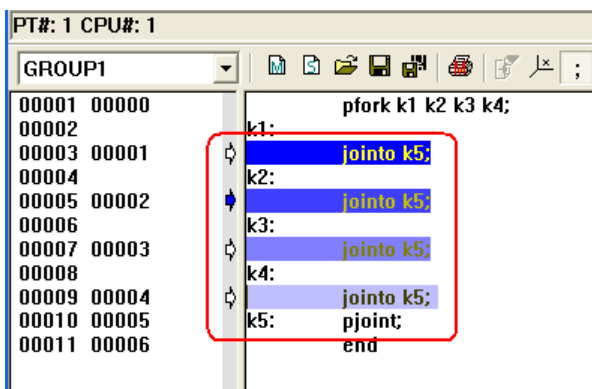
No.18 Mistake of current step in PFORK at debugging mode.

A current execution step had moved to the second parallel divergence when step into/step over to PFORK. This was corrected because there was such a problem.

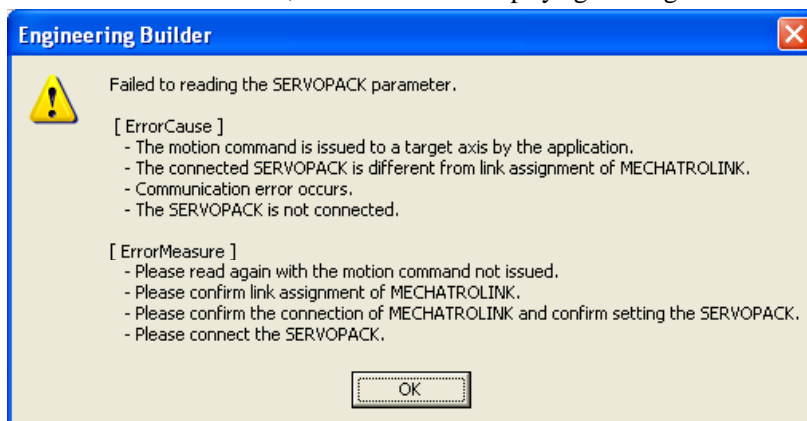
No.21 Trouble when the current value of SERVOPACK is acquired.

Even if reading failed in the acquisition of the current value from SERVOPACK, it was normally occasionally displayed that it had ended. Therefore, it corrected it like displaying warning.

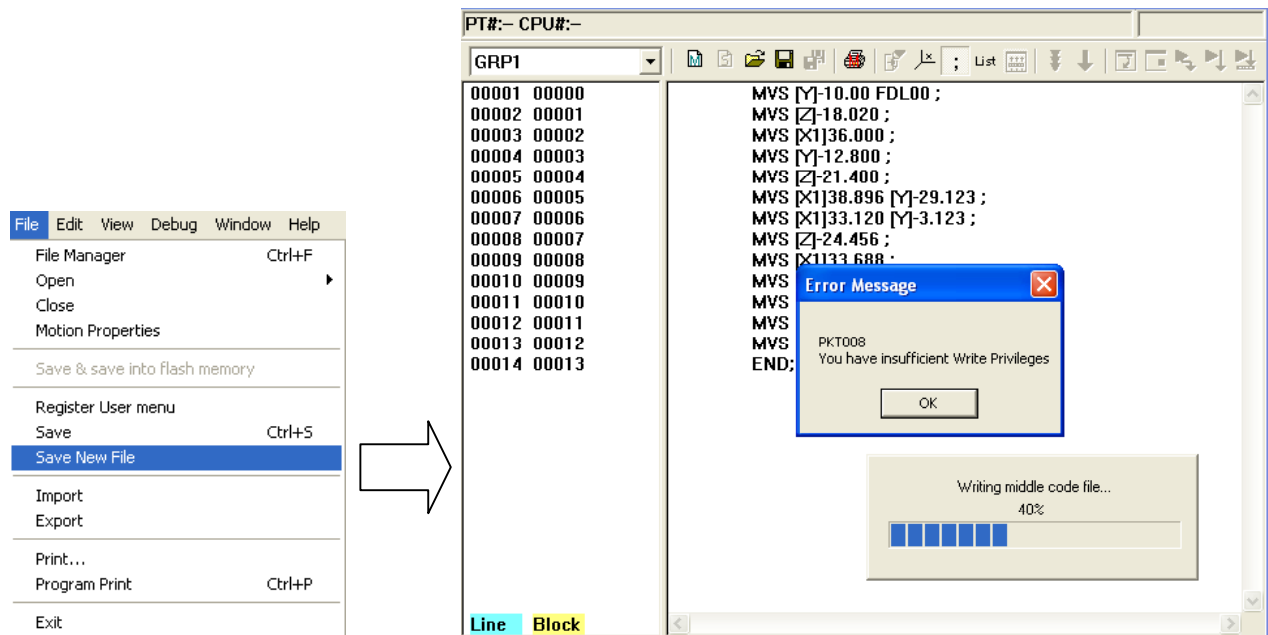
No.22 Bug of motion program saving privilege.

Because the error "You have insufficient Write Privileges" occurred if "Save New File" was executed for an existing motion program and it was not possible to save it, this was corrected.

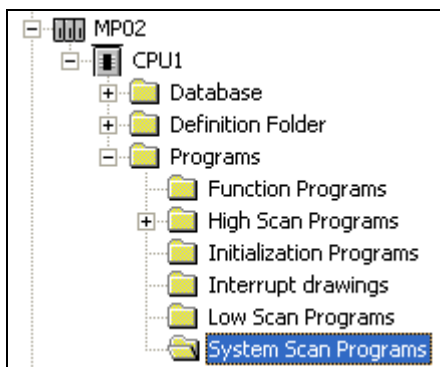
No.23 Bug of simple mode display.

When a simple mode was selected, "System Scan Programs" was being displayed even by the controller who was not supporting to "System Scan Programs" in the file manager. Therefore, this was corrected

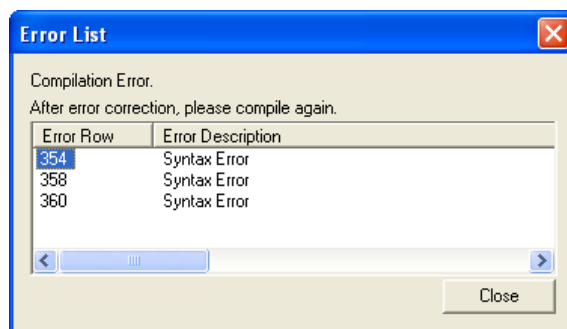
No.24 Bug of motion program single quote use.

When a single quote was used while commenting on the motion program, the compile error was occasionally generated. Therefore, this was corrected.

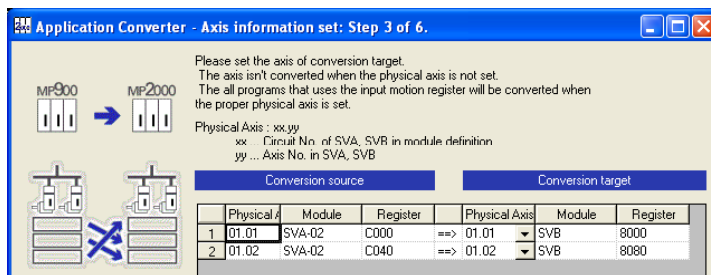
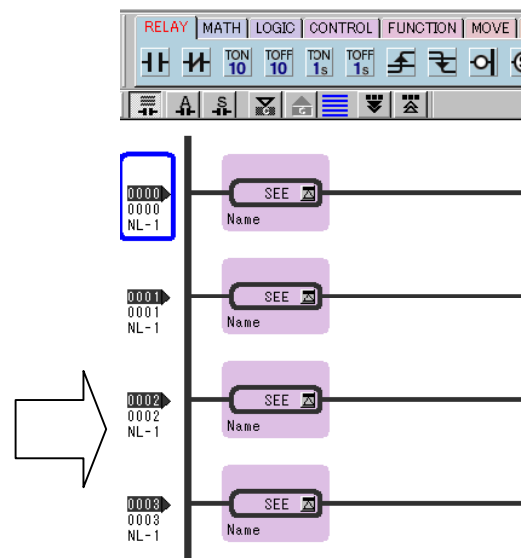
No.25 Bug of application converter.

When the application converter was executed, the drawing name specified by the SEE instruction in the drawing became an empty column occasionally. Therefore, this was corrected.
