## Upgrade Information of MPE720 Version 7.31

#### 1.1 Version 7.31 Upgrade Information

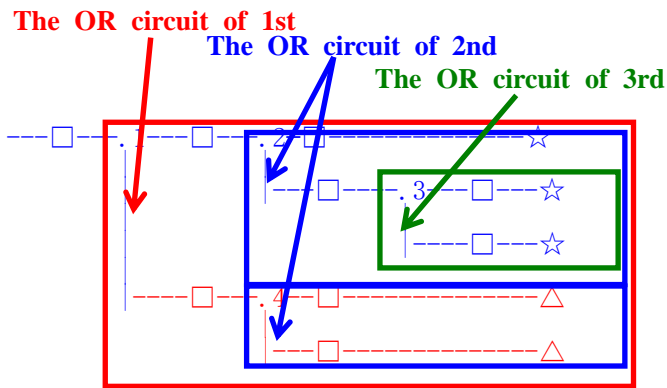
In the Ladder program of MPE720 Ver7 before MPE720 Ver7.23, when the parallel circuit is used, the following phenomena may occur.

When the circuit containing the following pattern was created, there was a phenomenon of operating without receiving the condition that the circuit below the OR circuit of 1<sup>st</sup> class must operate essentially in response to the conditional instruction before the OR circuit of 1<sup>st</sup> class.

When a phenomenon occurs, please carry out re-compile about the Ladder program in MPE720 Ver7 after MPE720 Ver7.24. Or please carry out again “Compile All Programs” of “Compile” menu.

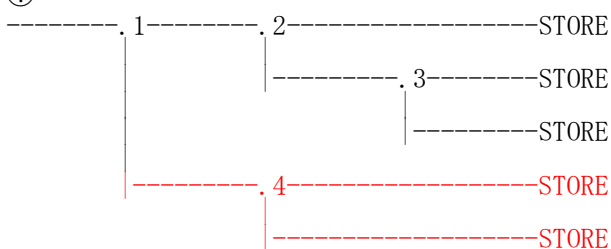
①

This pattern is minimum circuit pattern.

This is NG.

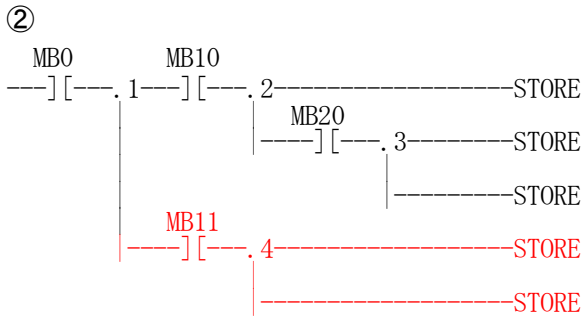
It is NG even if the minimum circuit pattern has conditional instructions (NO Contact etc.).

This is NG

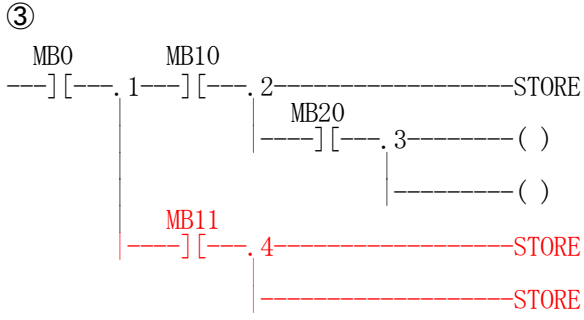
It is NG when there are at least one block commands (STORE command etc.) here.

This is NG

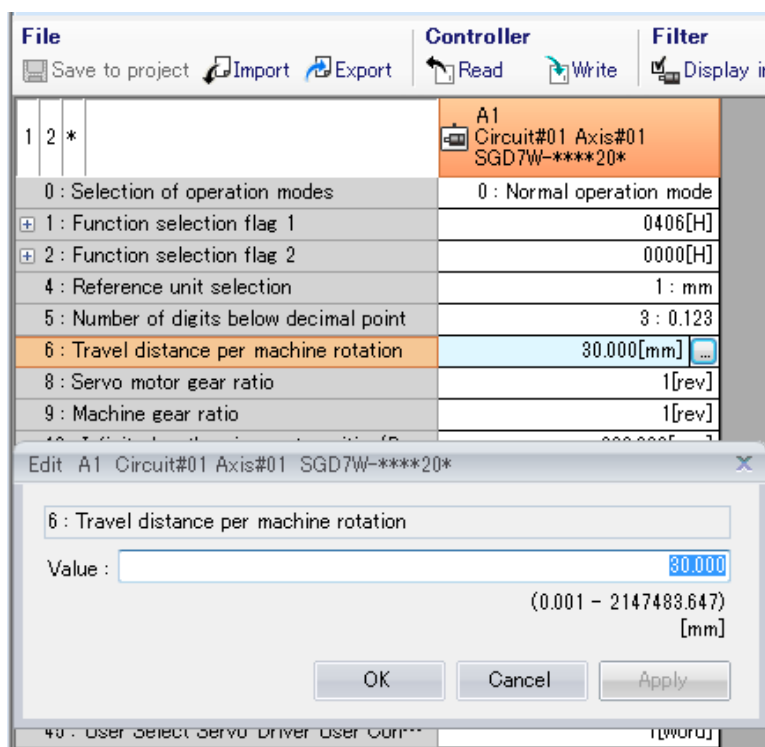
The language of OS (the language by which ", (comma)" is used for input in a decimal point) couldn't input a decimal point in a parameter screen of MC-Configurator (Ex. Fixed parameter No.6: Travel distance per machine rotation). So this has been improved.

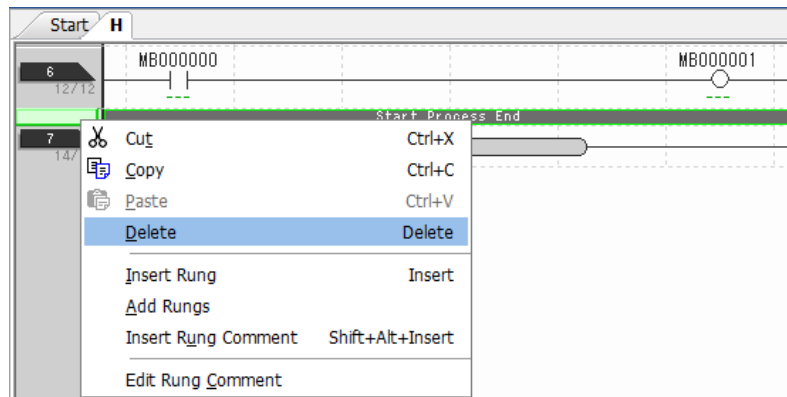
There was a phenomenon that it can't delete Lang comment of the last line in the Ladder Program (in front of END). So, this has been improved.

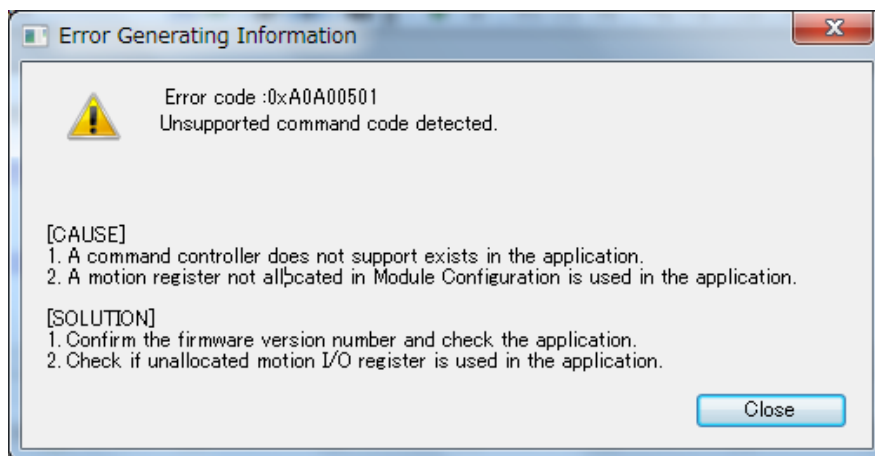
In the state which made an online connection to a controller, when writing the 18th axis defined in the Group Definition in the Motion Program and compiling, the error message of "Unsupported command code detected." was displayed. So this has been improved.
