Upgrade Information of MPE720 Version 7.33

1.1 Version 7.33 Upgrade Information

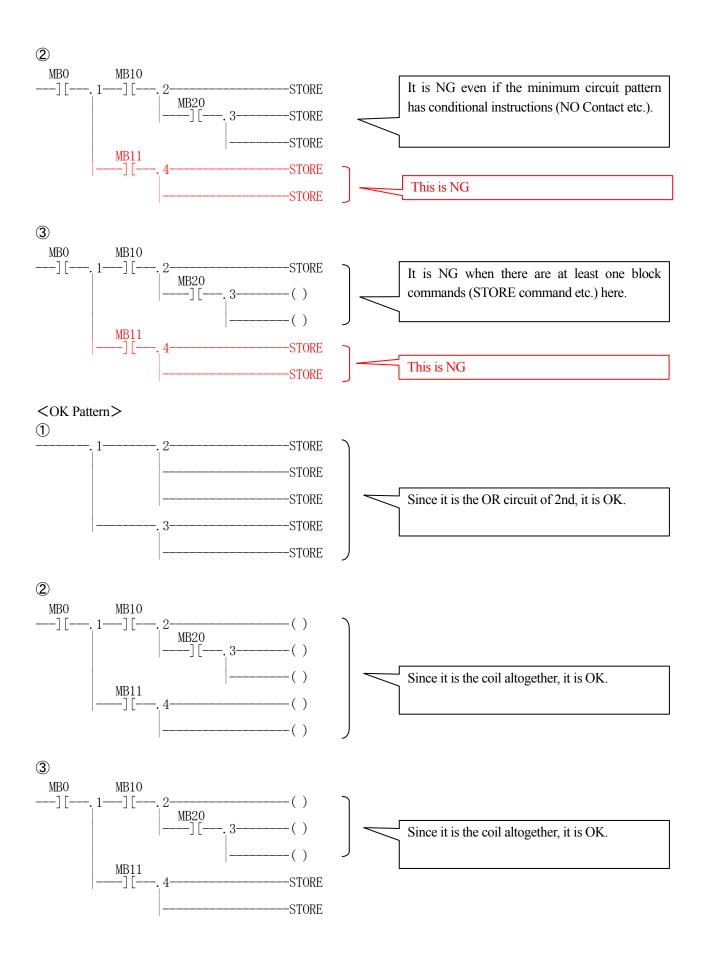
<NG Pattern>

In the Ladder program of MPE720 Ver7 before MPE720 Ver7.23, when the parallel circuit is used, the following phenomena may occur.

When the circuit containing the following pattern was created, there was a phenomenon of operating without receiving the condition that the circuit below the OR circuit of 1st class must operate essentially in response to the conditional instruction before the OR circuit of 1st class.

When a phenomenon occurs, please carry out re-compile about the Ladder program in MPE720 Ver7 after MPE720 Ver7.24. Or please carry out again "Compile All Programs" of "Compile" menu.
