## **Upgrade Information of MPE720 Version 7.64**

#### **1.1 Version 7.64 Upgrade Information**

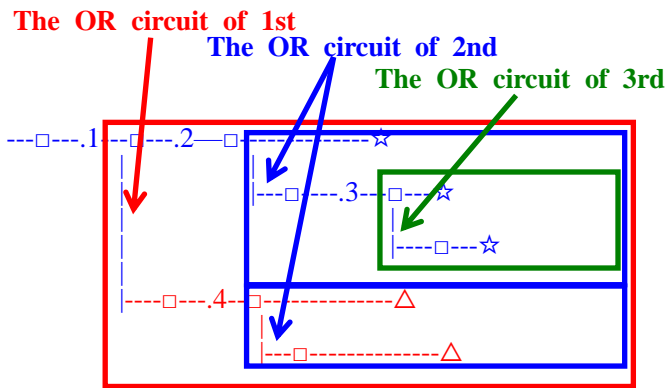
In the Ladder program of MPE720 Ver7 before MPE720 Ver7.23, when the parallel circuit is used, the following phenomena may occur.

When the circuit containing the following pattern was created, there was a phenomenon of operating without receiving the condition that the circuit below the OR circuit of 1<sup>st</sup> class must operate essentially in response to the conditional instruction before the OR circuit of 1<sup>st</sup> class.

When a phenomenon occurs, please carry out re-compile about the Ladder program in MPE720 Ver7 after MPE720 Ver7.24. Or please carry out again “Compile All Programs” of “Compile” menu.

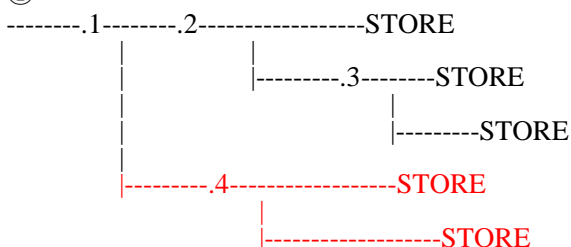
①

This pattern is minimum circuit pattern.

This is NG.

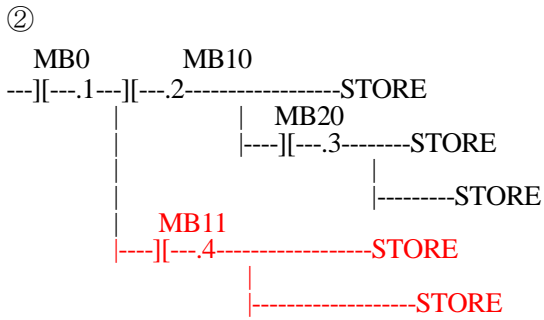
It is NG even if the minimum circuit pattern has conditional instructions (NO Contact etc.).

This is NG

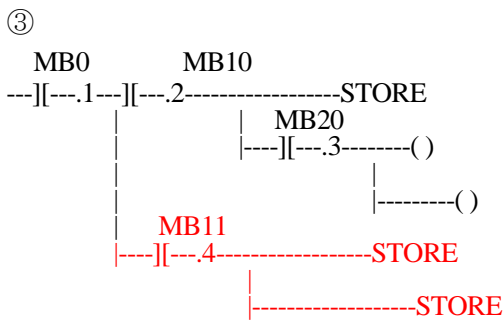
It is NG when there are at least one block commands (STORE command etc.) here.

This is NG

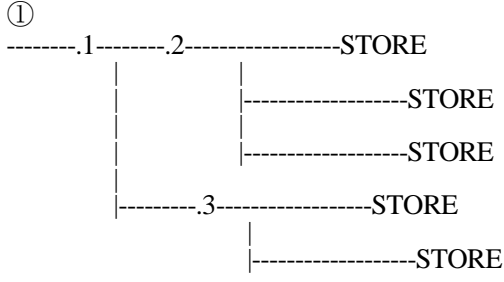
Since it is the OR circuit of 2nd, it is OK.

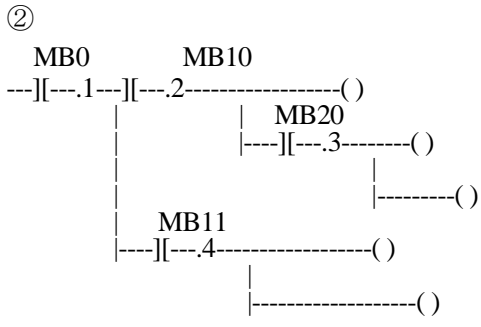
Since it is the coil altogether, it is OK.

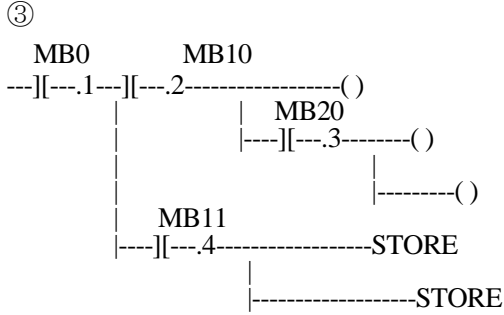
Since it is the coil altogether, it is OK.

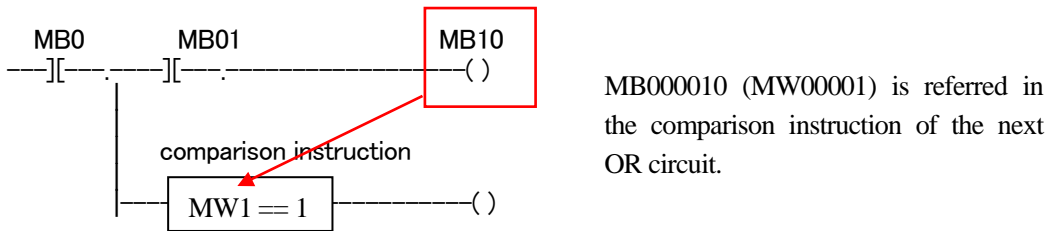
In the Ladder program of MPE720 Ver7 before MPE720 Ver7.63, when a comparison instruction is used in branch, the following phenomena may occur.

When the circuit containing the following pattern was created, the value of the register set in the upper OR circuit must be reflected to the comparison instructions in the lower OR circuit in the same scan. However, there was a phenomenon that it was reflected in the next scan.

When a phenomenon occurs, please carry out re-compile about the Ladder program in MPE720 Ver7 after MPE720 Ver7.64. Or please carry out again “Compile All Programs” of “Compile” menu. Also, about these programs that include circuits with this pattern, the number of internal steps will change in Ver7.64 or later, so when cross-reference is performed in a project created in an earlier version, there is a possibility of jumping to an unintended location. In this case, please recompile too.
