Upgrade Information of MPE720 Version 7.65

1.1 Version 7.65 Upgrade Information

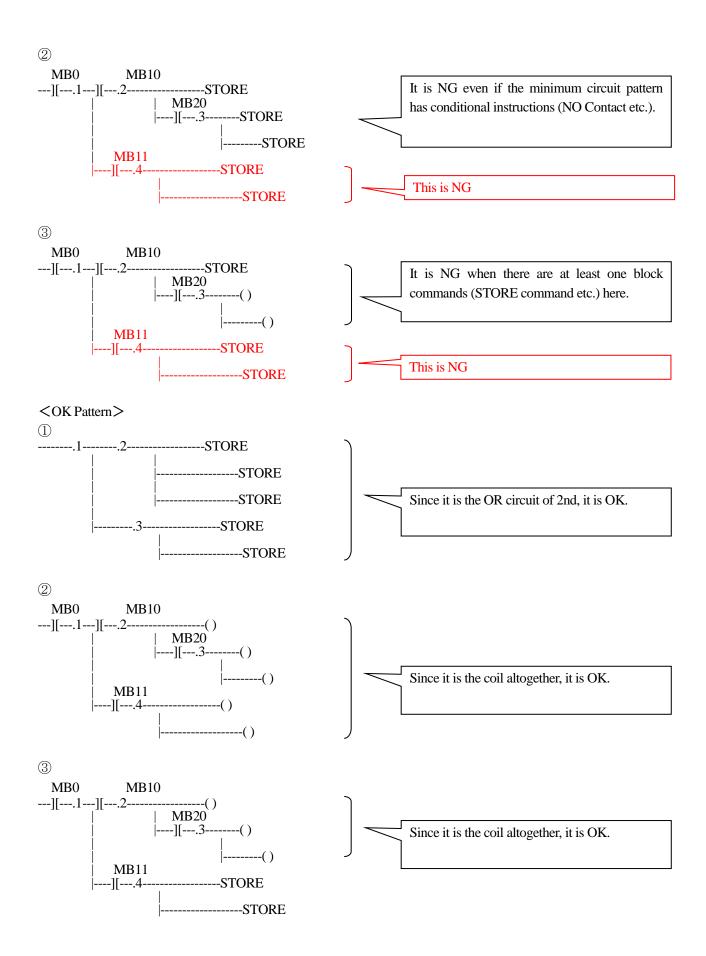
In the Ladder program of MPE720 Ver7 before MPE720 Ver7.23, when the parallel circuit is used, the following phenomena may occur.

When the circuit containing the following pattern was created, there was a phenomenon of operating without receiving the condition that the circuit below the OR circuit of 1st class must operate essentially in response to the conditional instruction before the OR circuit of 1st class.

When a phenomenon occurs, please carry out re-compile about the Ladder program in MPE720 Ver7 after MPE720 Ver7.24. Or please carry out again "Compile All Programs" of "Compile" menu.
