MPE720 Ver.7.86 version upgrade information

1.1 Ver.7.86 version upgrade information

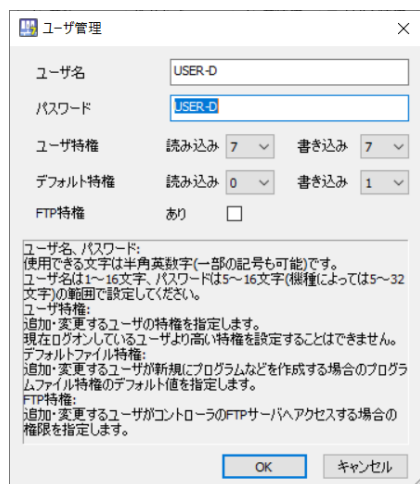
No.5 Fixed a bug that prevented FTP setting in the user control window in CPU-203 project.

1) You can set FTP privilege on the user control window of the target controllers.

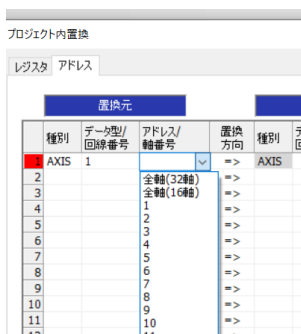
In the project for YRM-X controllers, there was a problem in which the selection of the axis number when the type "AXI" S was selected was up to 32 axes when the within-project replacement was executed. Thus, we have corrected this so that up to 64 axes can be selected.

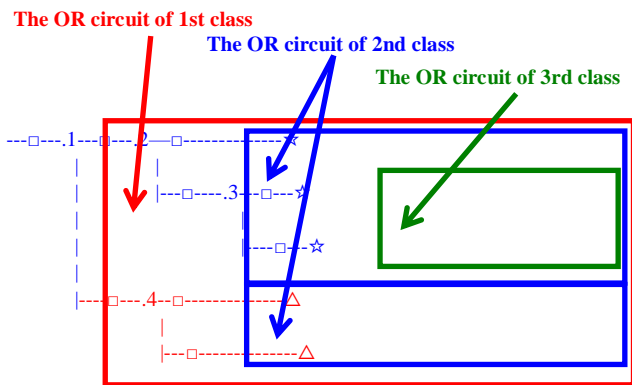
In the Ladder program of MPE720 Ver7 before MPE720 Ver7.23, when the parallel circuit is used, the following phenomena may occur.

When the circuit containing the following pattern was created, there was a phenomenon of operating without receiving the condition that the circuit below the OR circuit of 1st class must operate essentially in response to the conditional instruction before the OR circuit of 1st class.

When a phenomenon occurs, please carry out re-compile about the Ladder program in MPE720 Ver7 after MPE720 Ver7.24. Or please carry out again "Compile All Programs" of "Compile" menu.

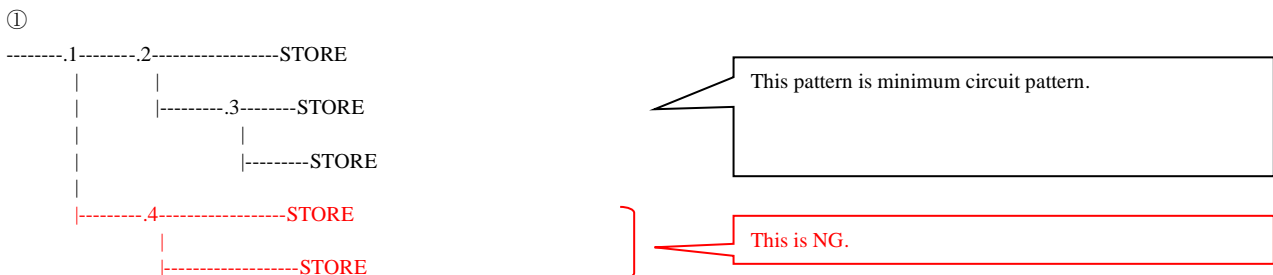
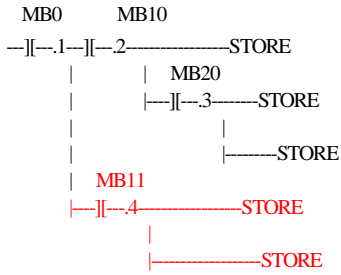
<NG Pattern >

It is NG even if the minimum circuit pattern has conditional instructions (NO Contact etc.).

It is NG when there are at least one block commands (STORE command etc.) here.

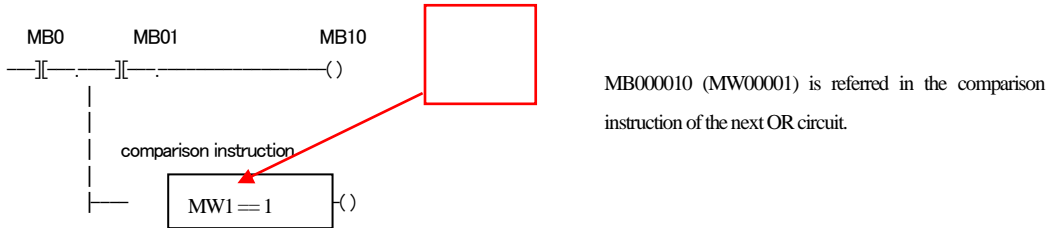
In the Ladder program of MPE720 Ver7 before MPE720 Ver7.63, when a comparison instruction is used in branch, the following phenomena may occur.

When the circuit containing the following pattern was created, the value of the register set in the upper OR circuit must be reflected to the comparison instructions in the lower OR circuit in the same scan. However, there was a phenomenon that it was reflected in the next scan.

When a phenomenon occurs, please carry out re-compile about the Ladder program in MPE720 Ver7 after MPE720 Ver7.64. Or please carry out again “Compile All Programs” of “Compile” menu. Also, about these programs that include circuits with this pattern, the number of internal steps will change in Ver7.64 or later, so when cross-reference is performed in a project created in an earlier version, there is a possibility of jumping to an unintended location. In this case, please recompile too.
