MPE720 improvement item and bug fix change

1. Function addition and improvement item

2. Correction content explanation

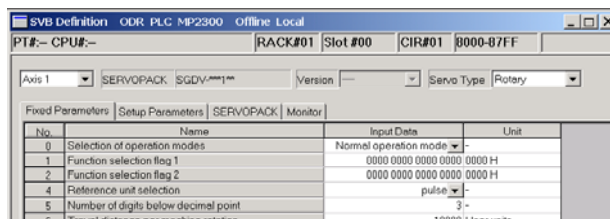
No.1 Support to Sigma-5 Servopack

It supported to SGD_V-***1** that was the new Servopack.

*: Please apply the following versions when you use this Servopack.

SVB with built-in controller is used: Since MP2000 system software version 2.61.

Option SVB is used: Since SVB-01 system software version 1.22.

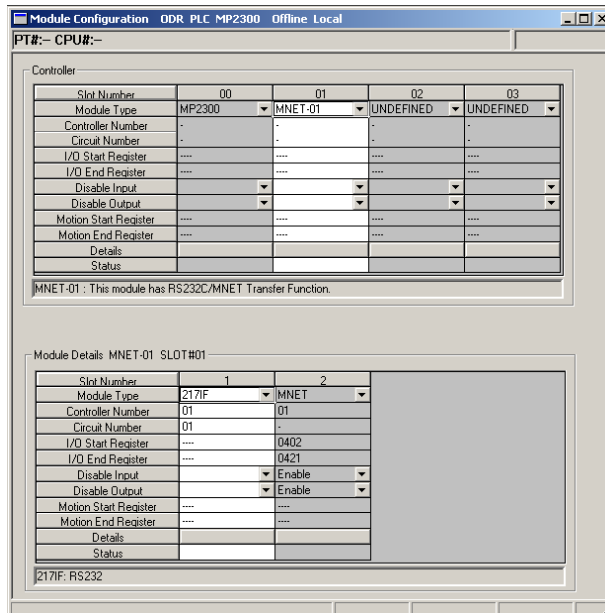
No.2 Support to MNET-01 module

It supported to the MNET-01 module that was the new option module. The MNET-01 module has the function of 217IF and MNET.

*: This module can be used since MP2000 system software version 2.61.

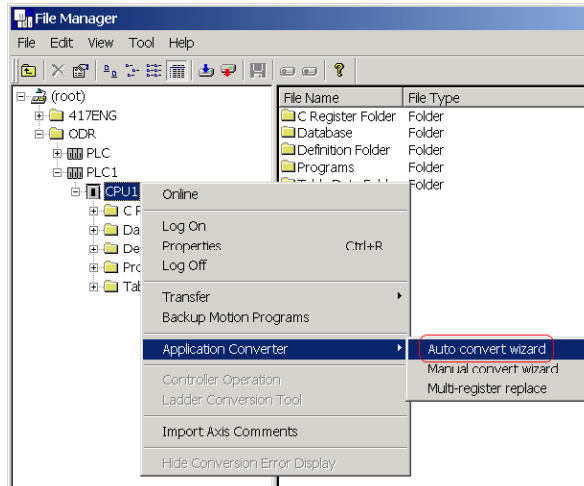
- The auto convert function of the module was supported.

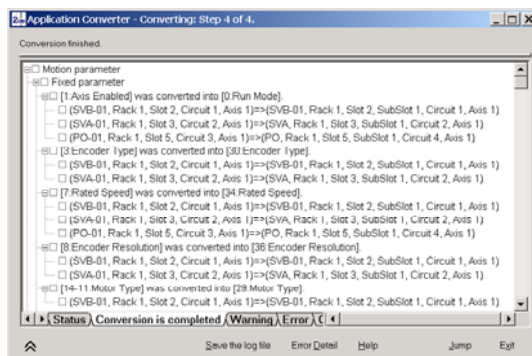
- The conversion rule of the parameter was reviewed.

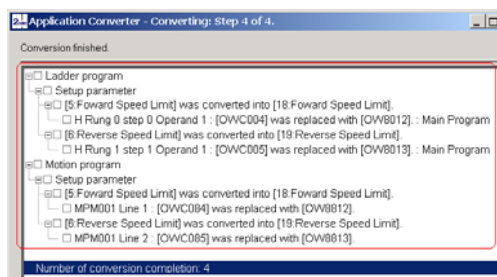
- The display format of the log was changed (support of the tree view).

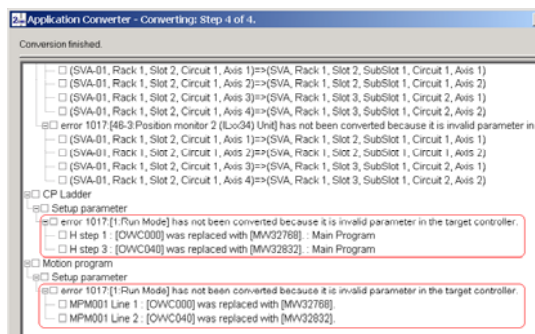
-: The register that was not able to be converted was converted into an unused M register area with MP900.

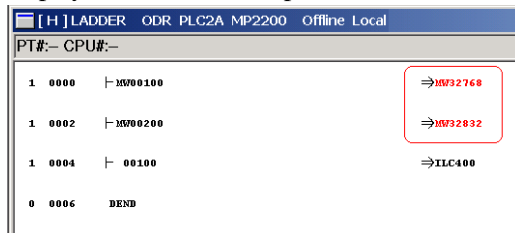
- After it had converted it, the register for which the replacement was necessary made the conversion part display in red-letter, and specified.

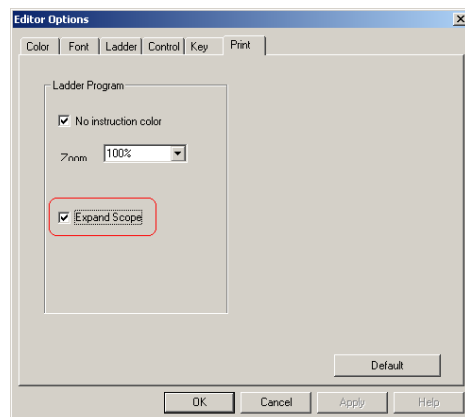
No.4 Scoping expand print of new ladder (improvement).

The new ladder program was able to be printed with Scoping ON.

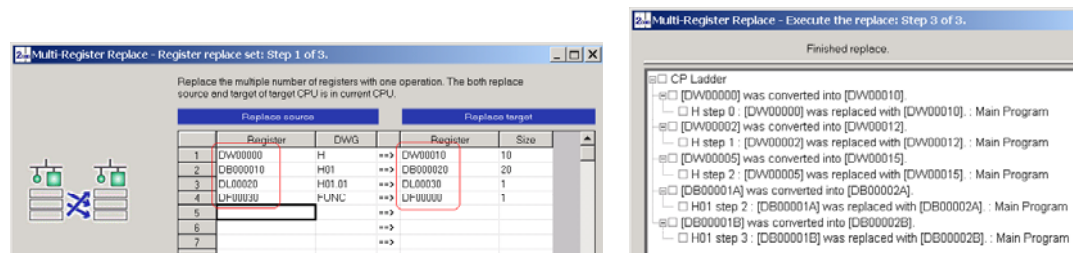
No.5 Support to D register of Multi-register replace (improvement)

To replace D register of DWG, "Multi-register replace" function has been improved.

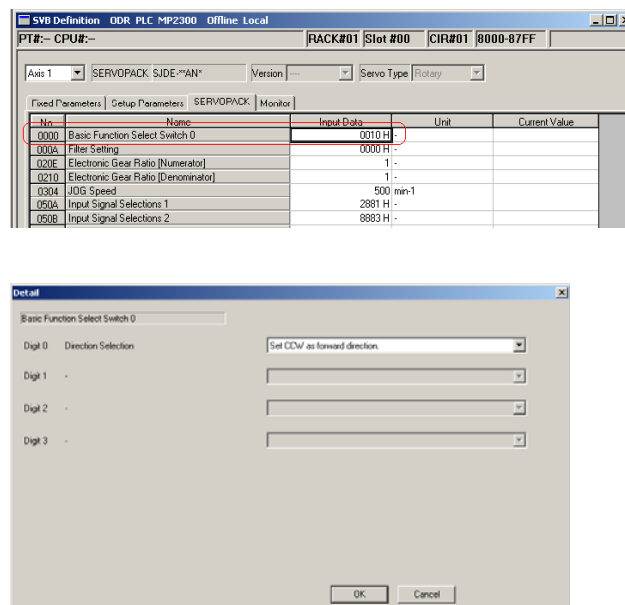
No.7 Support to user constant Pn0000 of SJDE-**AN*

User constant Pn0000 of SJDE-**AN* was made a parameter that was able to be operated.
