# **Upgrade Information of MPE720 Version 5.41**

## 1. Added and Improved Functions

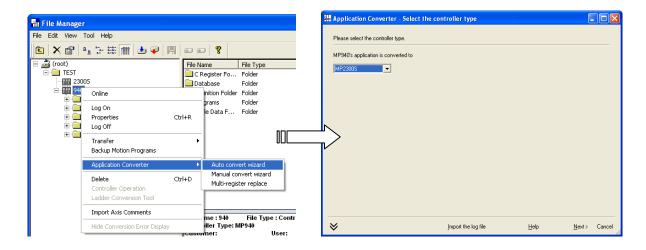
## No.1 Support to MP940 of application converter.

MP940 can be selected at target of automatic conversion in the application converter.

Target controller: MP940/ MP940M/ MP940D

MP940	Enable to convert
WIP940	to MP2000 series controller
MP940/MP940M	MP2300
	MP2310
	MP2300S
MP940D	MP2300
	MP2310

- \*: S drawing is cannot be converted in the MP2000 series.
- \*: S register is without target of application converter.
- \*: S scan is converted into H scan when converting to the MP2000 series.
- \*: MLINK definitions of MP940M is converted into M-II (32 byte/ 0.5ms) in the MP2300S.

I/O modules allocated to MLINK definition are converted into \*\*\*\*\* I/O when there is no convertible M-II compatible module, because I/O module cannot use in the M-II.
- \*: When 261IFS has been selected of 6th slot of MP940, it is without target of application converter.

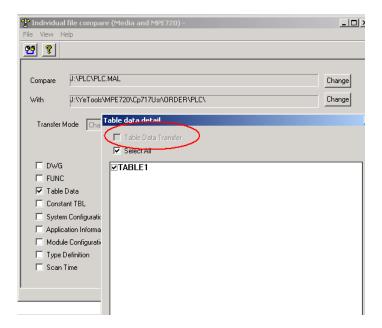
## No.2 Support to Comparison processing of table data.

Both online/ off-line table data were added to the comparison target though data table was without target of the comparison.
