Upgrade Information of MPE720 Version 5.44

1. Added and Improved Functions

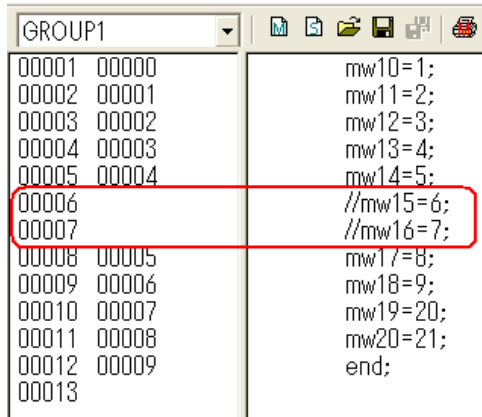
No.1 Support to one-line comment instruction in motion program.

One-line comment instruction "//" was added to the motion program.

This instruction treats from "//" to line feed as a comment.

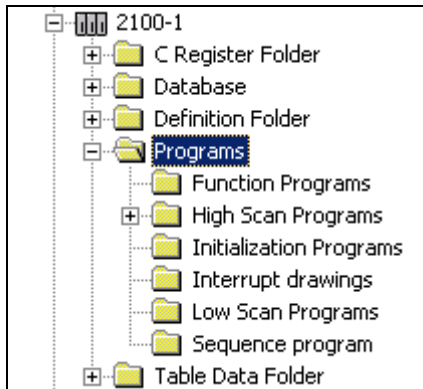
No.4 Support to sequence program function.

It supported to the sequence program function with MP2100/MP2100M.

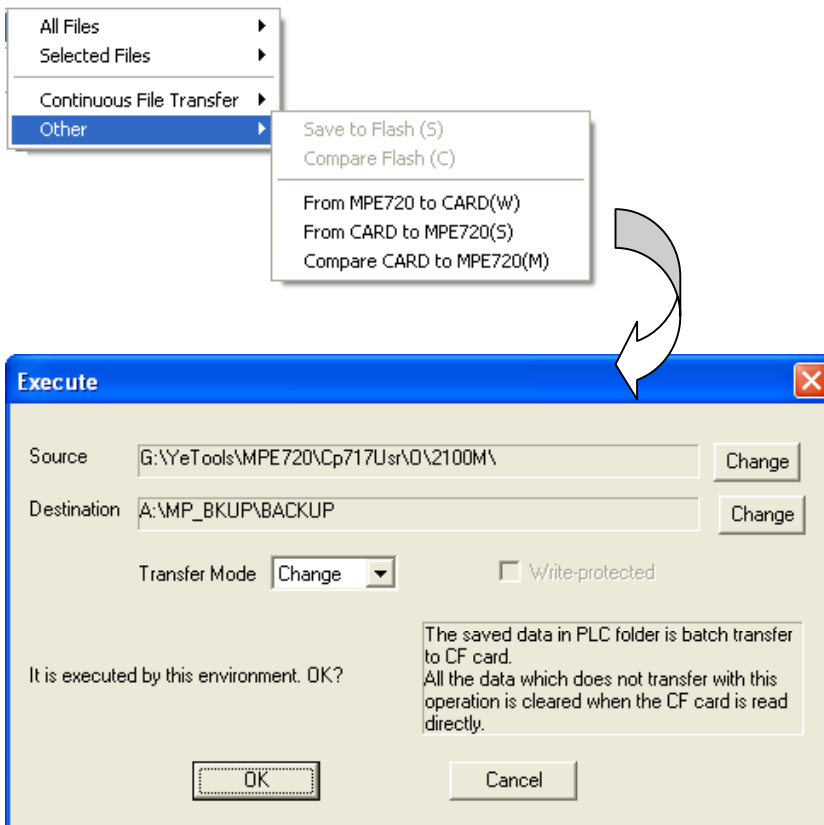
No.5 Support to CF card transfer function.

The CF card transfer function that had been supported up to now only when MP2200-02 was selected was developed with the MP2000 series all models.
