# Upgrade Information of MPE720 Version 7.34

### 1.1 Version 7.34 Upgrade Information

Items added and features improved from MPE720 version 7.33 to version 7.34 are as follows.

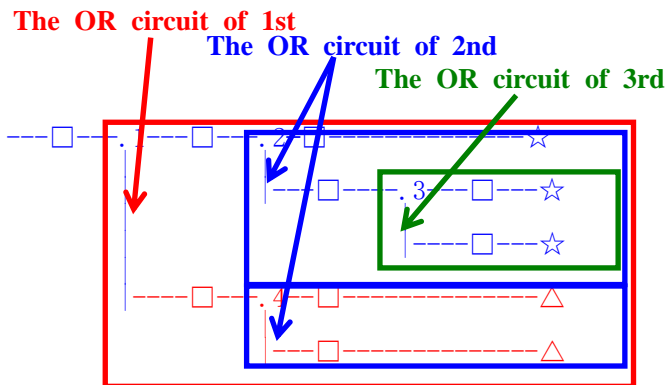
When the circuit containing the following pattern was created, there was a phenomenon of operating without receiving the condition that the circuit below the OR circuit of 1<sup>st</sup> class must operate essentially in response to the conditional instruction before the OR circuit of 1<sup>st</sup> class.

The OR circuit of 1st class: The OR circuit branched from the bus-bar of language.

The OR circuit of 2nd class: The OR circuit branched out of the OR circuit of 1st class.

The OR circuit of 3rd class: The OR circuit branched out of the OR circuit of 2nd class.

□(Conditional instruction): NO Contact, NC Contact, Coil, instruction(==, !=, >, <), power line (-----) etc.

☆(Output instruction): Coil, Block instruction(Expression, STORE, COPYW) etc

In the Ladder program of MPE720 Ver7 before MPE720 Ver7.23, when the parallel circuit is used, the following phenomena may occur.

When a phenomenon occurs, please carry out re-compile about the Ladder program in MPE720 Ver7 after MPE720 Ver7.24. Or please carry out again “Compile All Programs” of “Compile” menu.

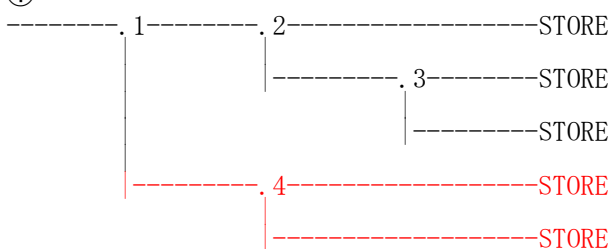
①

This pattern is minimum circuit pattern.

This is NG.

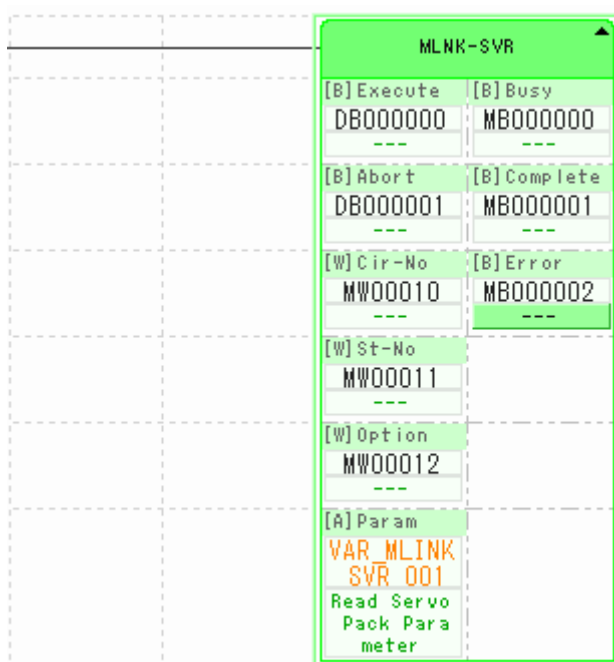
#### •Read Servo Pack Parameter (MLNK-SVR)

It reads in a parameters in a lump from the RAM area of the servo pack of the specified Circuit number and axis number. And overwrite the parameters that are stored in the machine controller as a backup file of the servo pack parameters. By using this function, when performing the exchange of servo pack, even if there is no tool such as MPE720, it can read the servo pack parameters in the ladder processing.

1. We added the MLNK-SVR instruction to the ladder instruction tree.
2. We added the MLNK-SVR instruction to the compilation process of the ladder instructions
3. We added structure of the MLNK-SVR instruction to the system structure.

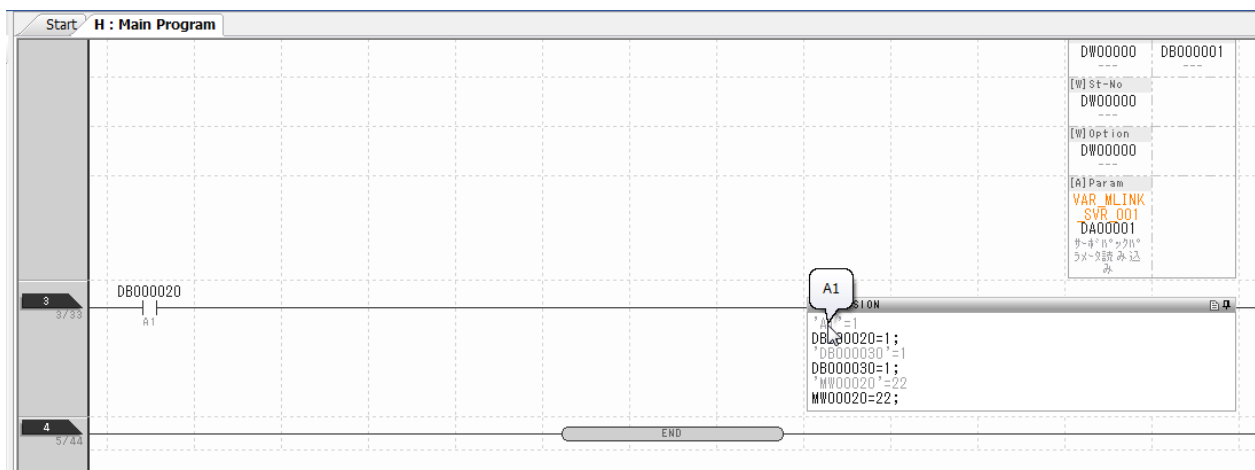
#### No. 4 We added the function to display the register comment to the "Expression Instruction".

1. We added the function to display the register comment to the "Expression Instruction".
2. We added the function of setting the number of display characters of register comments to the "Display" in the "Environment Setting".
3. We added the ability to display the register comments balloon help when mouse cursor was put on the register comments.

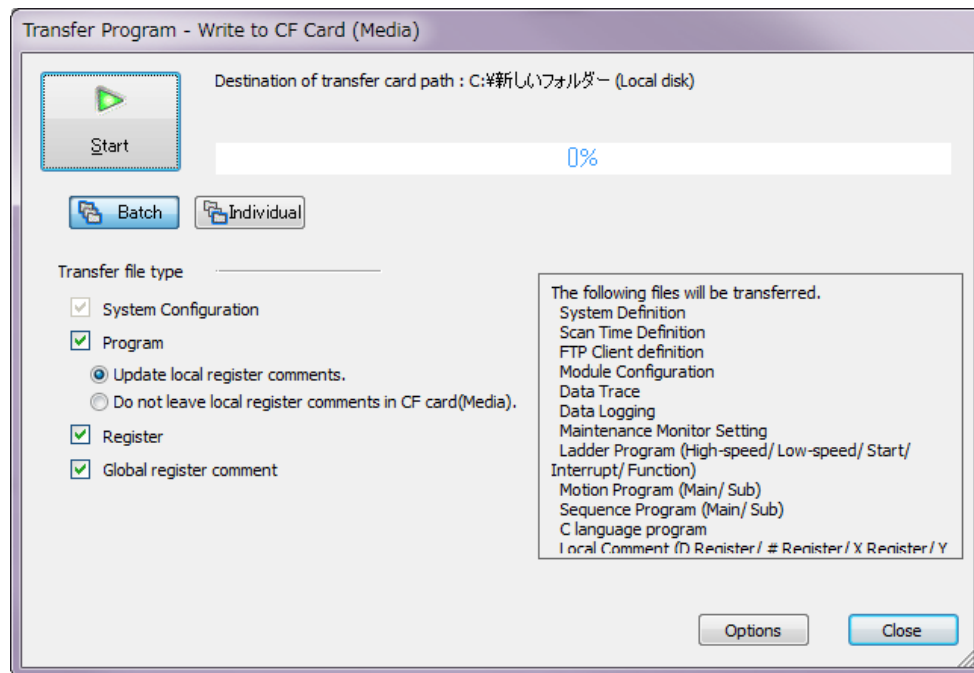
In the "Writing to the CF card (Media)" of the transfer function, it was supported the "Individual Transfer" function.

Target	Format	Support
MP controller' s		×
User memory (folder specification)	Compressed 2.0MB Division	○
	Compressed 2.0MB Division	○
	Compressed 2.0MB Division	○
	MP2000CF card backup	×

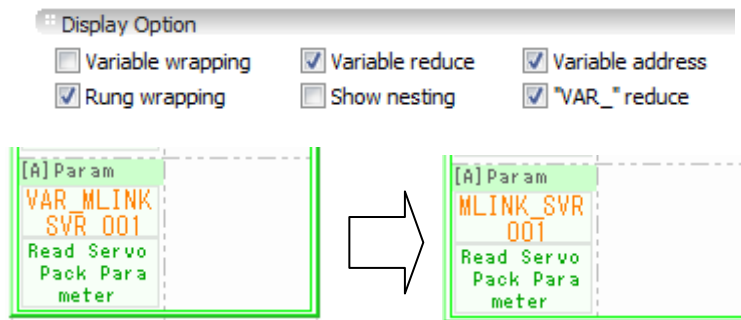
We added the setting of omit display of 'VAR\_' of the prefix to the "display" in the Environmental Setting screen. If it sets the function, prefix of 'VAR\_' is shown omitted.

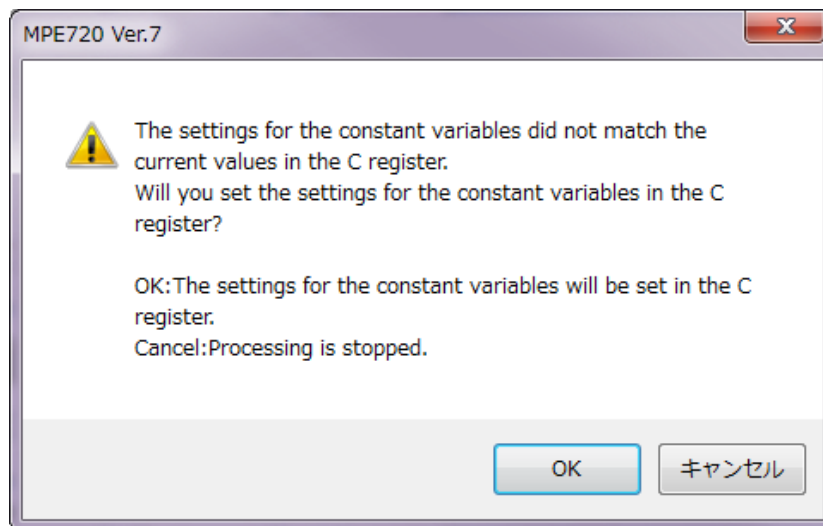
If it used the constant variable check function, it was only possible to write the definition of the constant variable (set value) to the current value when the definition of the constant variable (set value) and the comparison of the current value result were a mismatch. So, in the confirmation message, we added the cancel button to be able to cancel the write operation.

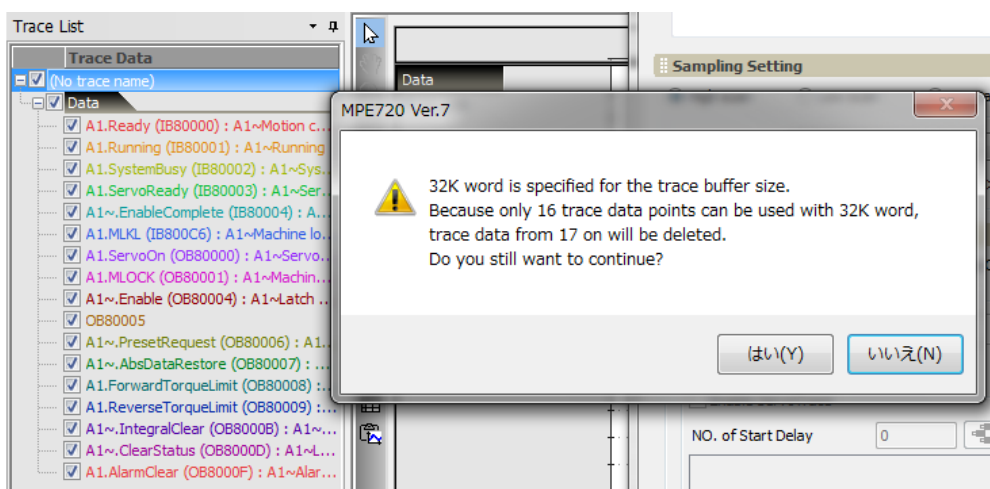
When 17 points or more registers data were registered in the definition data, import error occurs when you run "Open trace file" in the real-time trace function. In addition, there was a phenomenon that MPE720 was shut down at the timing that opened the trace data setting screen. So, we improved the following improvements.

1. We have added the setting of trace buffer size in the export data.
2. When 17 or more points of the register has been registered when the trace buffer size was imported the trace definition data that had not been outputted, we improved to ask them to change the set value of the trace buffer size of the "Sampling& Trigger Setting" screen by shown a message of alarm.
3. If it registered the register 17 points or more, it sets the "32 [K word] 32K word" to "trace buffer size" of the "Sampling& Trigger Setting" screen and it presses "OK" button. Then we added the function to delete the registered number data so as to be 16 points.

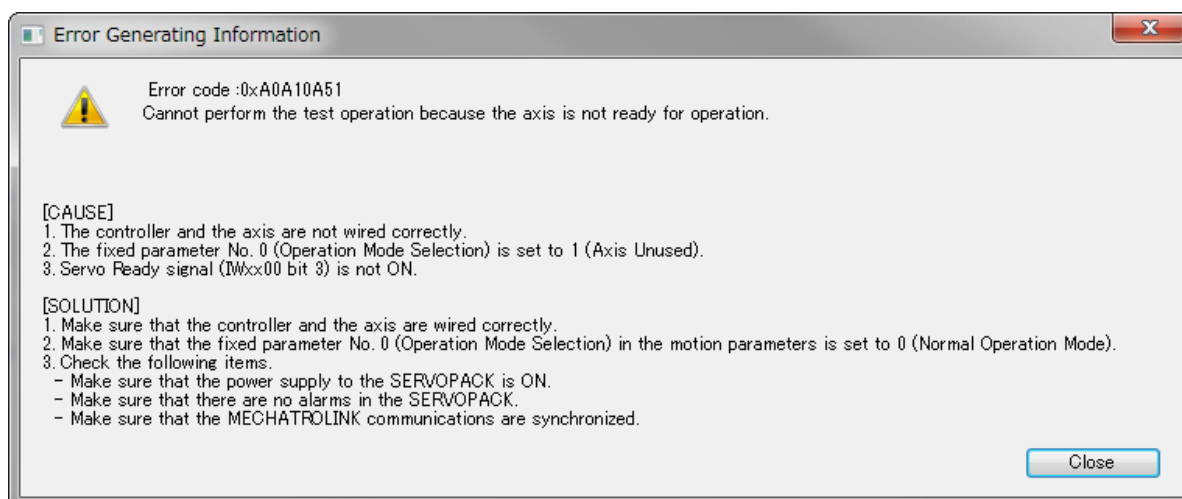
1. Make sure that the controller and the axis are wired correctly.
2. Make sure that the fixed parameter No.0 (Operation Mode Selection) in the motion parameter is set to 0 (Normal Operation Mode).
3. Check the following items.
  - Make sure that the power supply to the SERVOPACK is ON.
  - Make sure that there are no alarms in the SERVOPACK.
  - Make sure that the MECHATROLINK communications are synchronized.

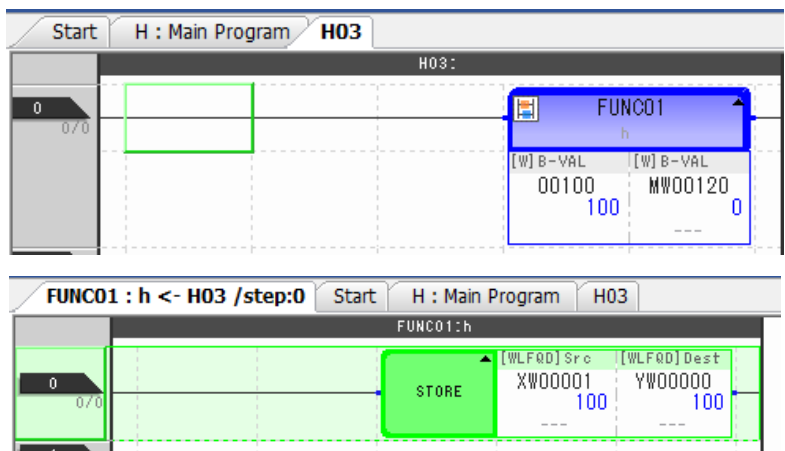
When it runs the "Open Program" from each ladder drawings, the called current value was not display correctly. So, we improved as the called current values were displayed correctly.

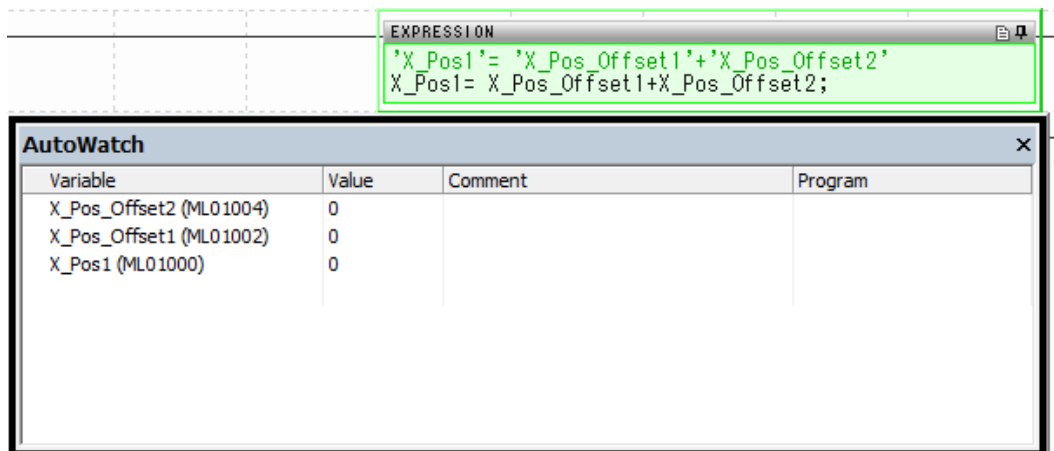
In the variable display mode, the variables that are used by the instruction, in the case of displaying the "Auto Watch" function has been improved so as to be displayed by the variable display.

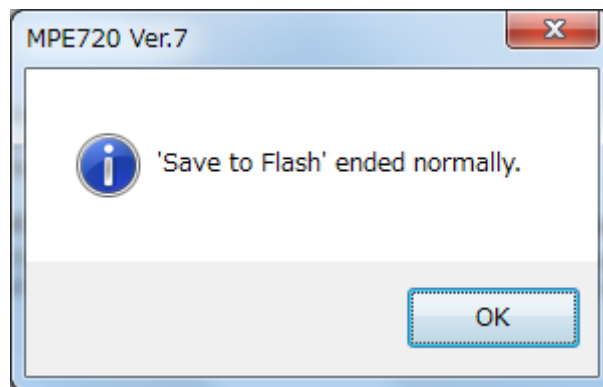
When carrying out background flash preservation continuously more than one times, processing of flash preservation was complete, but there was a phenomenon that the complete message isn't displayed. So, we improved the timing of indication of the back ground flash preservation completion message.
